## Rockfall Analysis and Protection Measures Recommendations at Eptahori Village, Epirus, Greece

This paper deals with a rockfall analysis in the northern steep slope at Eptahori Village, Epirus, Greece, which exhibits extended rockfall instabilities along its face, placing the village at the base of the slope at high risk. Along the examined slope, numerous older rockfall events were recorded. These rockfalls were caused by toppling of overhanging sandstone blocks formed by large tension cracks that were generated due to the erosion of the weak siltstone layers. The geological setting of the study area consists of molassic formations of “Eptahori” and “Pentalofos” units and more particularly by thick sandstone beds (“Pentalofos” unit) on the upper part of the slope, underlied by thin siltstone layers (“Eptahori” unit), which continues to the base of the slope. The structure of the rock mass is blocky, developed by bedding orientation NW – SE, dipping to the slope, which consists the main joint set of the rock mass as well by sub-vertical joints with orientation NNW – SSE within the thick sandstone layers (Figure 1). These joints act as tension cracks along the slope due to the lo

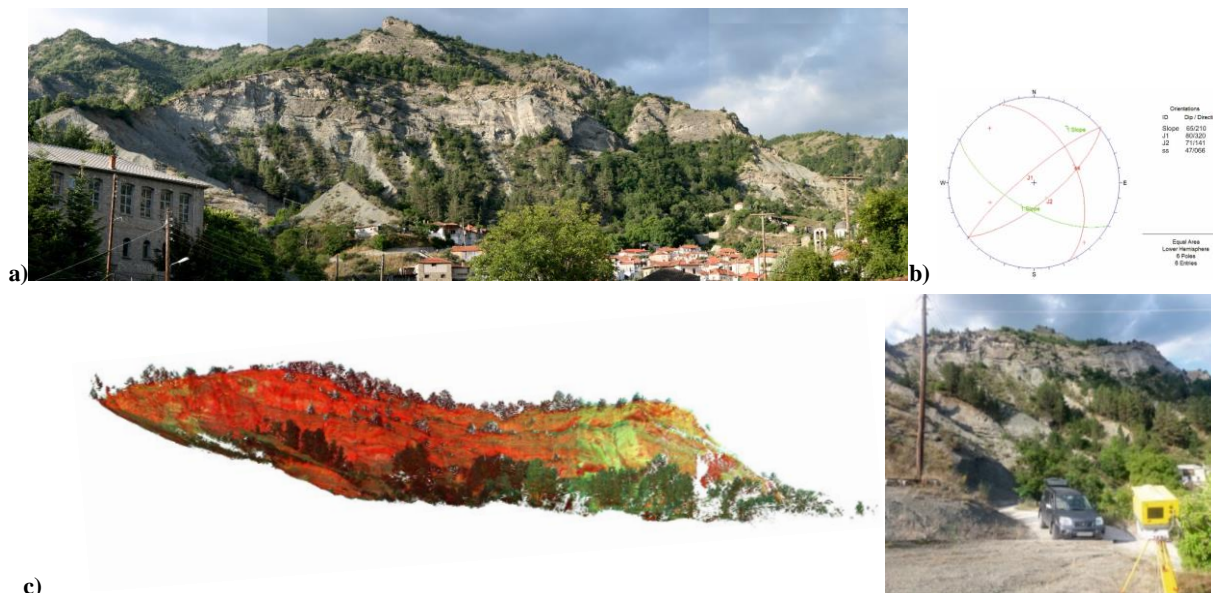
**Figure 1. (a) Face log of the slope to SW, (b) Major planes of the rock mass in Schmidt projection, (c) Resulting point cloud from LiDAR scanning**

The objective of this paper is to assess the engineering geological model of the rockfall events, to evaluate the degree of rockfall hazard along the face of the slope and finally propose the protection structures along the slope. A detailed field survey of the geological and engineering geological conditions was executed during July – August 2018 along with field measurements. Moreover, terrestrial laser scanning (Light Detection and Ranging – LiDAR) (Fig. 1c) as well as Unmanned Aerial Vehicle (UAV) flights above the study area were made. According to the resulting images and the generated point clouds, the slope morphology and block structures were precisely determined. The unstable zones were also detected and volume measurements of hanging blocks were carried out so as to develop the engineering geological model of the slope and evaluate the behavior of the formations prior to rockfall.

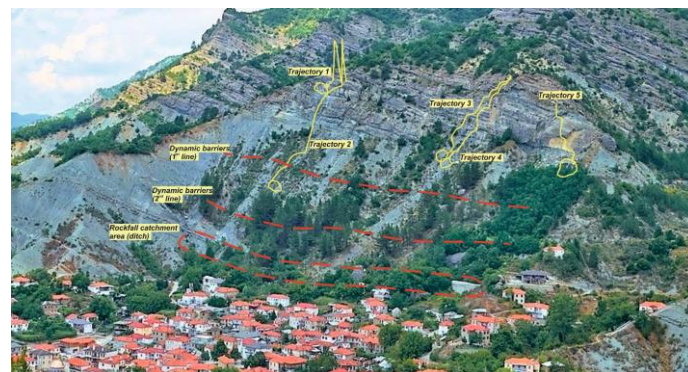
**Figure 3. Recommended construction sites of dynamic rockfall barriers and ditches at the toe of the slope.**

A series of protection measures – both active and passive – are proposed in order to reduce the hazard to the lowest possible level. Active structures aim to decrease the probability of failure by surface drainage of the slope by construction of drainage ditches and protection measures (e.g. sprayed polymer coatings) from the erosion of the siltstone members. Passive protection structures are strongly proposed as effective measures in order to retain falling blocks and absorb impact energy (Fig. 3). In particular, the measures proposed are:

- Dynamic rockfall barriers (or flexible catch fences) constructed in two lines at the toe of the slope, up to a height of 3 m and energy absorption capacity of up to 10,000 kJ for the first line and a height of up to 2 m and energy absorption capacity of up to 8,500 kJ for the second line. Of course, these very high energies concern the worst-case scenario of the analysis.
- Ditches (rock traps) constructed in front of barriers 2 to 5 m wide with depth up to 1 m filled with soil material for the absorption of average energy of 10,000 kJ.
