Documentation of the failures triggered by the July 20, 2017 Bodrum-Kos, Aegean Sea Mw=6.6 earthquake

Extended abstract

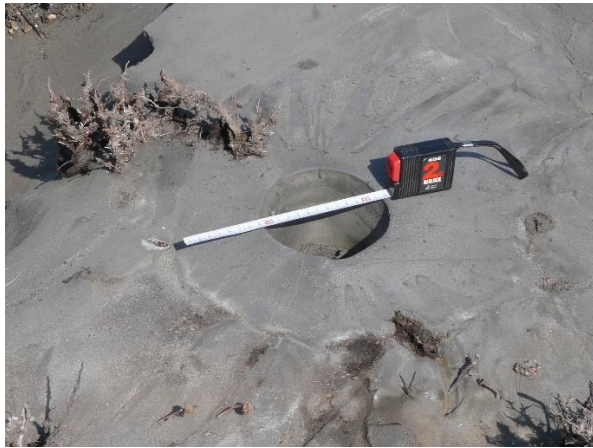
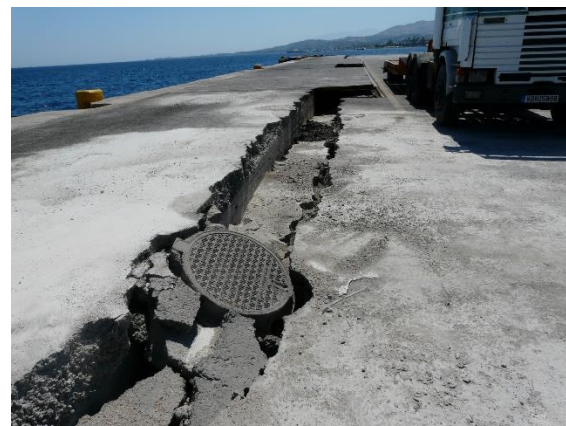
Figure 1. (upper left) Earthquake-induced ground failures at the cape Louros (photo taken by G. Papathanassiou on August 13, 2017), upper right) liquefaction manifestations at the area of marina that is used as a dry dock and for the maintenance and repairs of sailboats and yachts Louros (photo taken by G. Papathanassiou on August 13, 2017), lower left) lateral spreading phenomena induced damages to custom building (photo taken by G. Papathanassiou on August 14, 2017), lower right) failure at the new port of Kos (photo taken by G. Papathanassiou on August 14, 2017).

Based on the field observations, it can be summarized that the earthquake caused damages to the building stock of the town of Kos, mainly to Ottoman and Venetian-era constructions, including partial collapses that killed two people and seriously injured several others (Papathanassiou et al., 2019). Damages were also reported in the city of Bodrum. Focusing on the island of Kos, the most remarkable type of environmental effects is the liquefaction related phenomena that induced severe damages to the port facilities and to the custom building at the new port of Kos, and at the old harbor of the city. Moderate liquefaction-induced structural failures were induced at the marina of Kos, while at cape Louros ejected material due to liquefaction covered more than 450m^2 (Papathanassiou et al., 2019). Furthermore, a tsunami wave was reported indicating that the generation of tsunami-related phenomena e.g. flooding and structural damages is likely in the Aegean Sea. In particular, the tsunami effects were observed at the south coast of Bodrum peninsula and at the northeast coast of Kos Island, with a maximum run-up measured at 1.9 m at Bodrum area (Yalçiner et al., 2017). Small-scale size rockfalls were reported in the southern part of the island of Kos.
