Large Shear Box Testing on weathered zone of Flysch. The Case Studies of Panagopoula and Karya Landslides

S. Anagnostopoulou¹, N. Depountis¹, N. Sabatakakis¹

(1) Department of Geology, Patras University, 26504 Patras, Greece, geo09008@upnet.gr

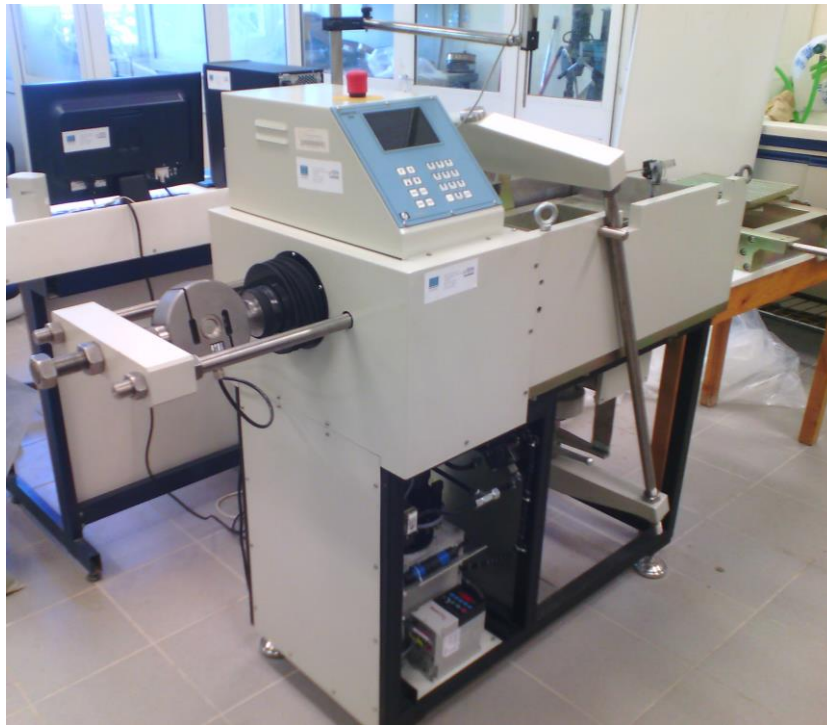
The Large Shear Box 300 (VJT2780A) apparatus (Fig.1) was used. From each type of weathered flysch, a series of tests were performed on prepared specimens with different water content and density in order study the effects of these parameters on the shear strength characteristics. Specimens were tested on dry, wet (partially saturated) and fully saturated conditions. Loose and dense specimens were also prepared to represent surficial and deeper zone of weathering.

Figure 1. Large Shear box apparatus.

Direct shear tests were performed on flysch sample grain fraction passing through the sieve No. 4 (<4.75mm) in accordance with ASTM standards (2004). Tests were performed using large shear box (300mm square about 160mm thick), soil samples under certain density - moisture conditions and three different normal stresses. The weathered flysch samples collected from the failure zone (weak zone) were classified according to USCS as clayey sands (SC) of medium plasticity with a small presence of well-graded gravels and a moisture content of 16-18%.

The different consolidation loads were left for one day in case of saturated conditions, whereas for a couple of hours until stabilization in case of dry tests. The shearing rate of the samples was very low in order to assure that no significant amount of pore water pressure would be developed at any stage of the test. All tests were regulated with the criteria to stop when the accumulated shear strain (γ) reached 10%.
